DISTRICT HEATING

APRIL, 1956 — VOL. XLI, No. 4

Museum Piece is Unearthed¹

76 Year Old Unusual Heating System Junction Box Discovered

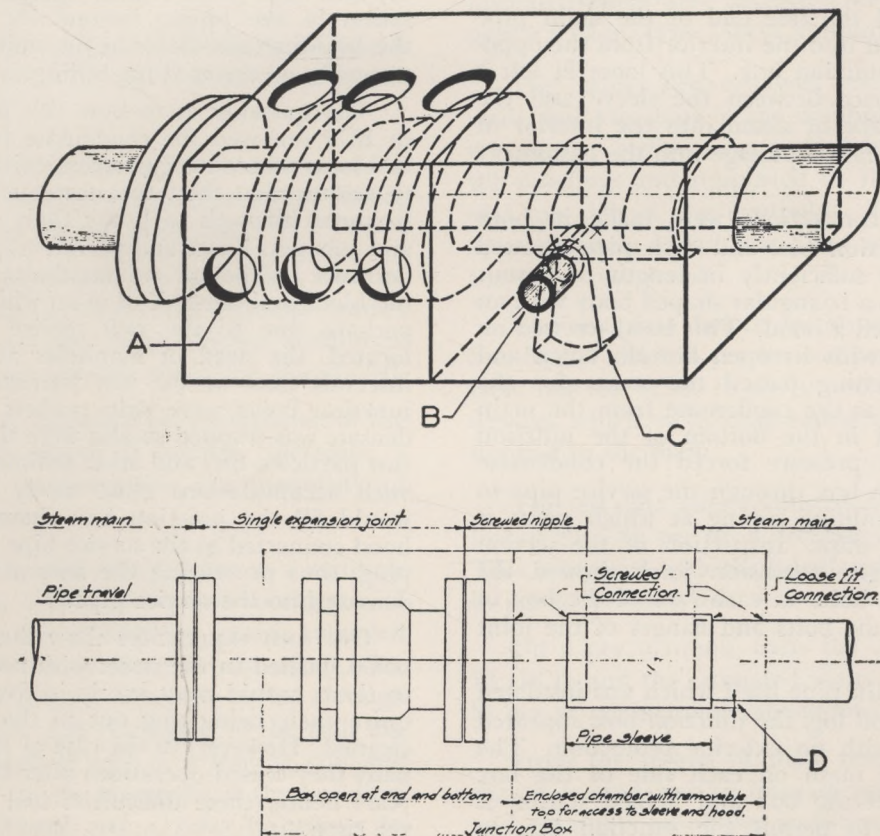
¹"For 1879 it was pretty good!" A pioneer heating system junction box installation with expansion joint and service outlet. "A"—access holes located in top and sides of junction box; "B"—screwed nipple of service connection to junction box; "C"—hood open at

bottom screwed to service nipple inside of junction box permits passage of steam and condensate from box to service—service outlet and hood installed on both sides of junction boxes.

This particular junction box, for a 4" main, measured 30" in length and 12" in width and depth. It was of cast iron and the body was divided equally into two sections, one being a closed chamber with a removable top and the other being merely an extension of the top and sides of the closed chamber.

Unlike the main pipe itself which was insulated by paper and wood log, the junction box appeared to be installed with no exterior protection. The wood log of the main on each side of the box butted up against the box and helped station it securely enough to permit the junction box to serve as an anchor for the expansion joint. As to the open side and bottom of the box section into which the expansion joint was inserted, it most
