National District Heating Association

EIGHT-INCH HIGH-PRESSURE, CONCRETE-ENCASED STEAM MAIN OF THE DULUTH STEAM CORPORATION

John C. Haroldson

(In this paper the author describes the 8 in., 150 psi steam line installed in Duluth in 1949.)

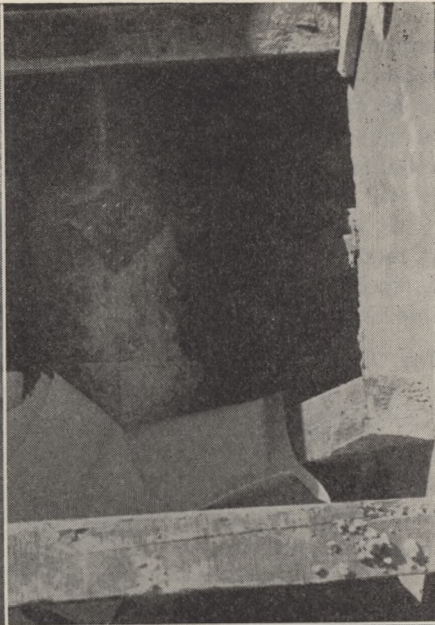
Sections of covering were placed around the pipe and held in position by stapling strips of tar paper across the joints, as shown in Fig. 4. One layer of 15 lb tar felt roofing paper was then wrapped around the covering. This was stapled in place. Of the several methods tried,

FIG. 4.—Sections of Foamglas Covering Showing Tar Paper Strip Stapled in Place.

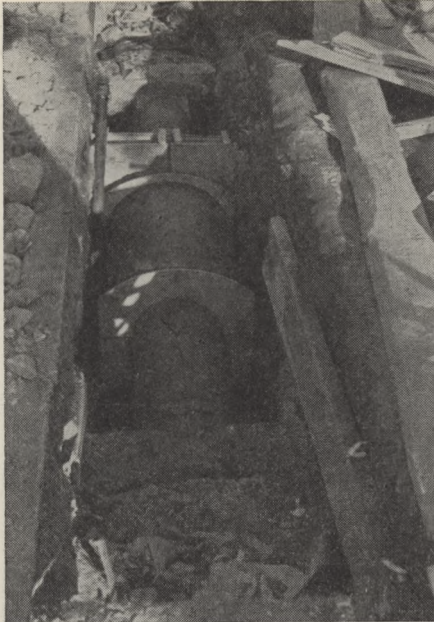
The expansion joint was welded into the line and then the galvanized tube was slid into position so that it covered the expansion element. A covering of double thick Fiberglas insulation was then placed around the galvanized metal tube and wired in place. A preformed $\frac{1}{8}$ in. sheet metal arch was next placed over the covering and wooden forms set in position at the ends of the arch as shown in Fig. 7 to keep the concrete out of the space housed by the arch.

The $1\frac{1}{4}$ in. listening tube was provided to aid in checking the joints for steam leaks. An anchor is shown in the foreground. The precast concrete tile was then slid along the line until one end extended about 3 in. into the space under the metal arch. This tile is 24 in. long and large enough in diameter so that it fits snugly around the pipe insulation. Two wooden forms were next placed around the tile, one about 6 in. and one about 12 in. from the metal arch, thus forming a 6 in. void. The purpose of this 6 in. void is to provide a space to take up any expansion of the concrete envelope itself. The tile acts as a gland being free to move in a horizontal direction through a watertight joint between the tile and the concrete envelope.

FIG. 7.—Section of Line at Expansion Joint Showing Anchor, Sheet Metal Arch, and Wooden End Forms.

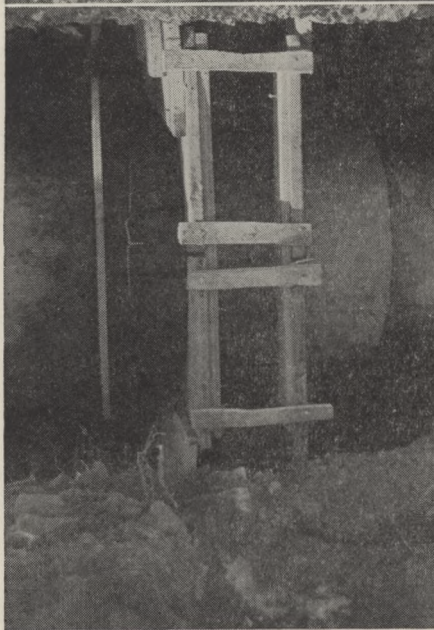
FIG. 9.—Section of Line at Expansion Joint Showing Asphalt Impregnated Mastic Strip in Place.

This joint, shown in Fig. 9, is made up of a strip of asphalt impregnated mastic 6 in. wide and $\frac{1}{2}$ in. thick, and is coated with Armorcote to assure a watertight joint. The concrete envelope was poured around the tile and metal arch as shown in Fig. 10. This type of construction eliminates the use of manholes for housing the expansion joints.
